Bridge Condition Survey

Inspection Date: 21 May 2003
District: San Angelo
County: Tom Green
Highway: Irving Street
Facility Name: Lone Wolf Bridge
Structure Number: B00315-031
Load Rating: See load rating report dated 7/2/03
Sufficiency Rating: 22 according to 10/17/02 NBI
Proposed Work: Condition survey and pedestrian rating

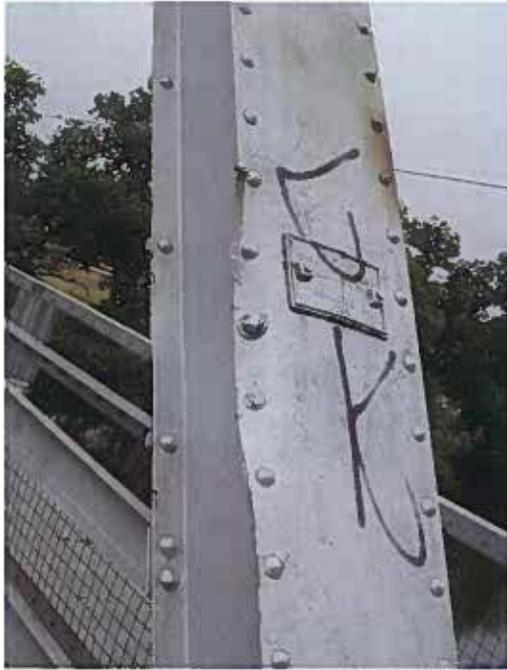
Minor impact damage

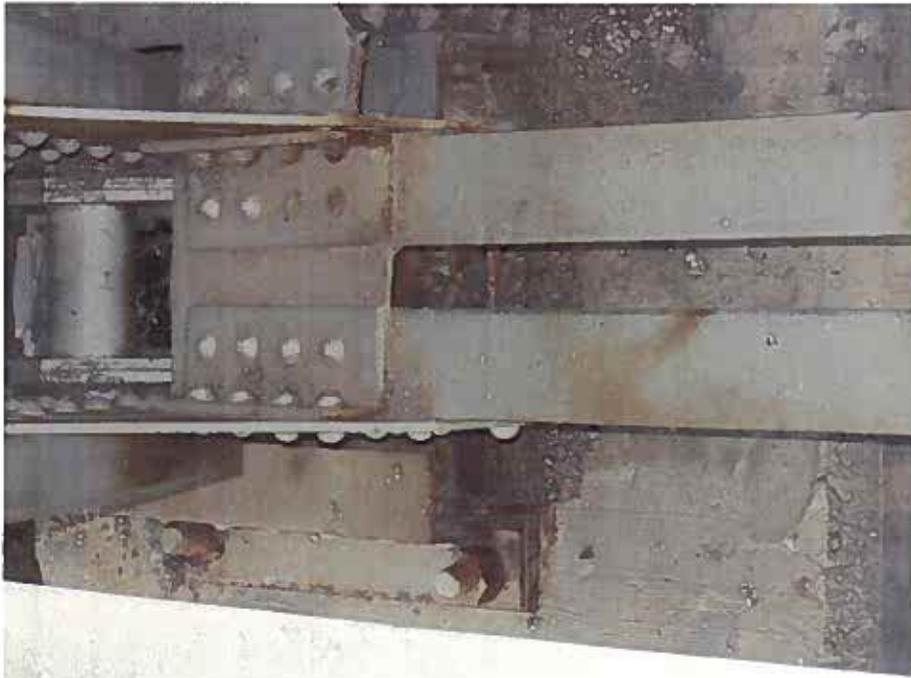
**Bearing at the end post connection
Debris and pack rust is typical at these four bearings**

1. Install new rail that meets current standards for pedestrian use. Contact BRG for assistance with the new rail selection.
2. Remove the sidewalk from the truss.
3. Repair the spalled concrete at the sidewalk deck connection (refer to photos) according to Item 429, "Concrete Structure Repair".
4. Power wash the truss with a 5000 psi pressure washer. A zero degree nozzle is required.
5. Remove debris, mills scale, corrosion, and paint rust from the bearing areas, and floor beam/ vertical connections using an approved surface preparation method.
6. Paint the truss with an over coating system. Contact BRG for assistance in selecting a system.
7. Grease all bearings.

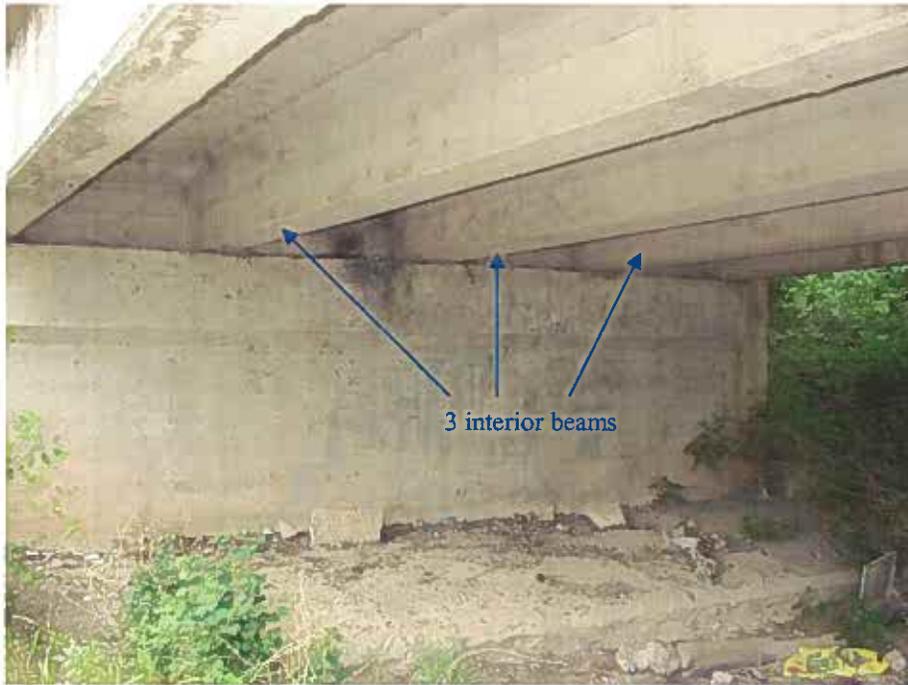
East Abutment

**The abutments are in good condition
The three interior beams are also in good condition
The exterior beams are in poor condition**

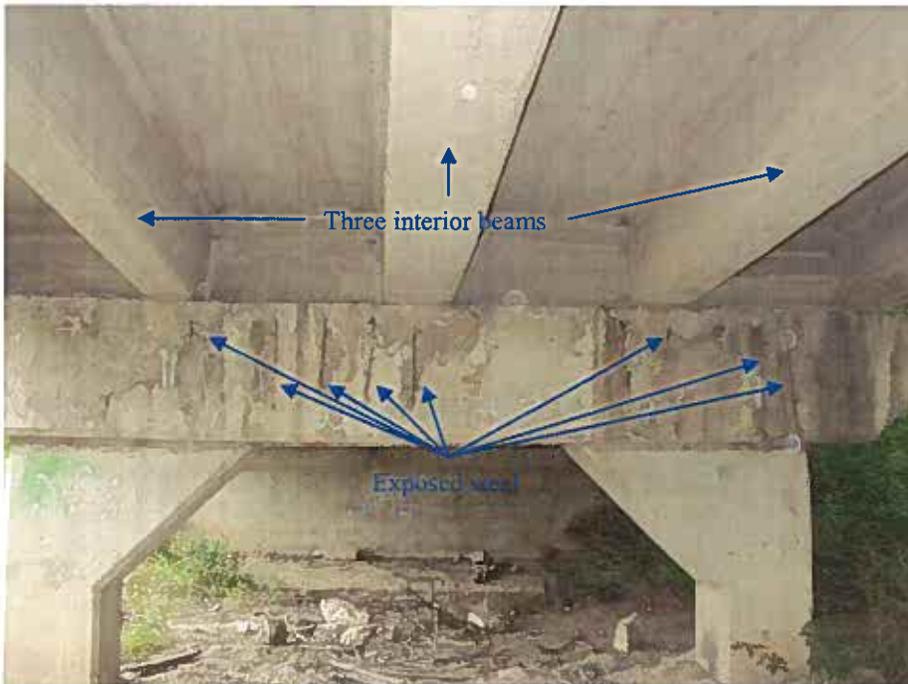
Foundations: The concrete columns and caps on the approach spans have spalled concrete exposing the reinforcement. The reinforcement did not have the required concrete cover causing the pop outs and spalling. The exposed steel has approximately 10-20% section loss. The masonry pier walls are in good condition. No settlement was noted.

**Typical concrete spalling and exposed reinforcement on the concrete caps
The spalling is attributed to the reinforcement steel having insufficient cover
There are 8 exposed stirrups**

1. Remove the sidewalk.
2. Repair exterior beams, concrete curb, columns, bents and abutments according to Item 429, "Concrete Structure Repairs".
3. Install new pedestrian rail that meets current standards. Contact BRG for assistance with the new rail selection.
4. Clean all joints and reseal as required.
5. Treat the remaining beams, exposed bents and abutments with a penetrating concrete surface treatment such as silane.

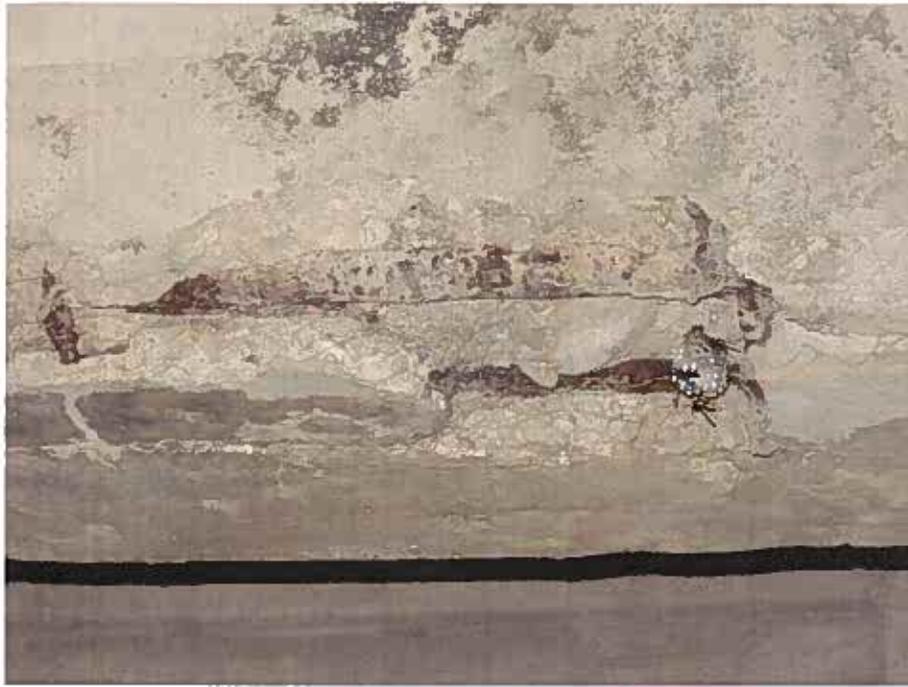
Concrete Tee beams: The exterior beams are in poor condition with severe spalling, delaminations, numerous stirrups exposed, and unsound concrete, which is a direct result of insufficient concrete cover. The exposed reinforcement has approximately 30% section loss.

**East side approach spans
Exterior beam @ South side
Typical spalled concrete due to insufficient concrete cover
Approximately 30% section loss**

1. The exterior beams, curb, and concrete rail are in very poor condition with significant amounts of exposed reinforcement, corrosion, and concrete spalling. Therefore, I recommend removing the exterior beams, curb, concrete rail and the sidewalk, which is no longer required. This will reduce the pedestrian roadway to the three interior beams.
2. Repair the spalled concrete on the columns, bents and abutments according to Item 429, "Concrete Structure Repairs".
3. Install new pedestrian rail that meets current standards. Contact BRG for assistance with the new rail selection.
4. Clean all joints and reseal as required.
5. Treat the remaining beams, exposed bents and abutments with a penetrating concrete surface treatment such as silane.

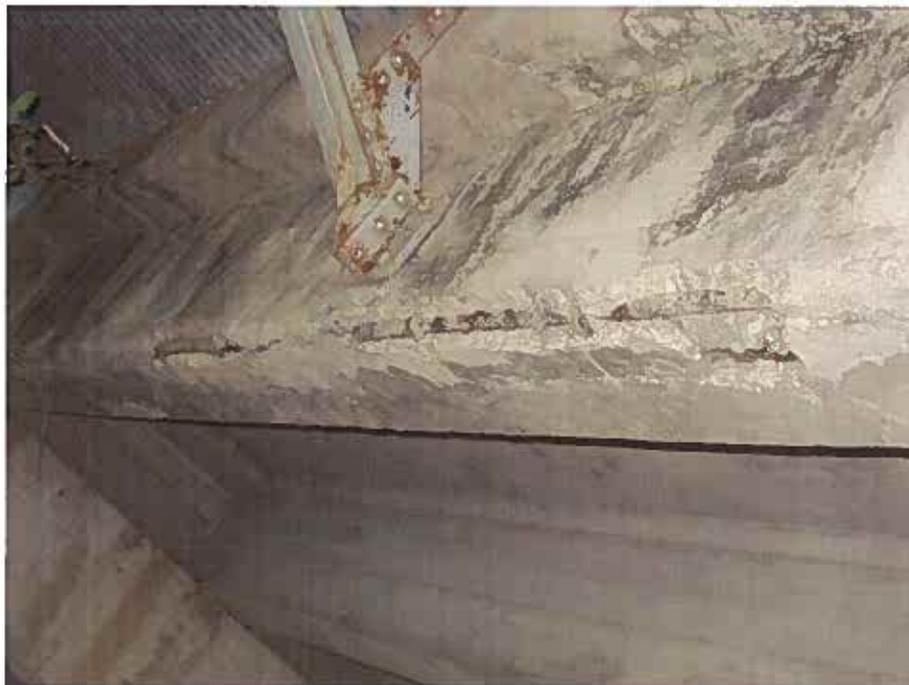
**East side approach spans
Approximately 10' of exposed reinforcement
Typical of exterior beams**

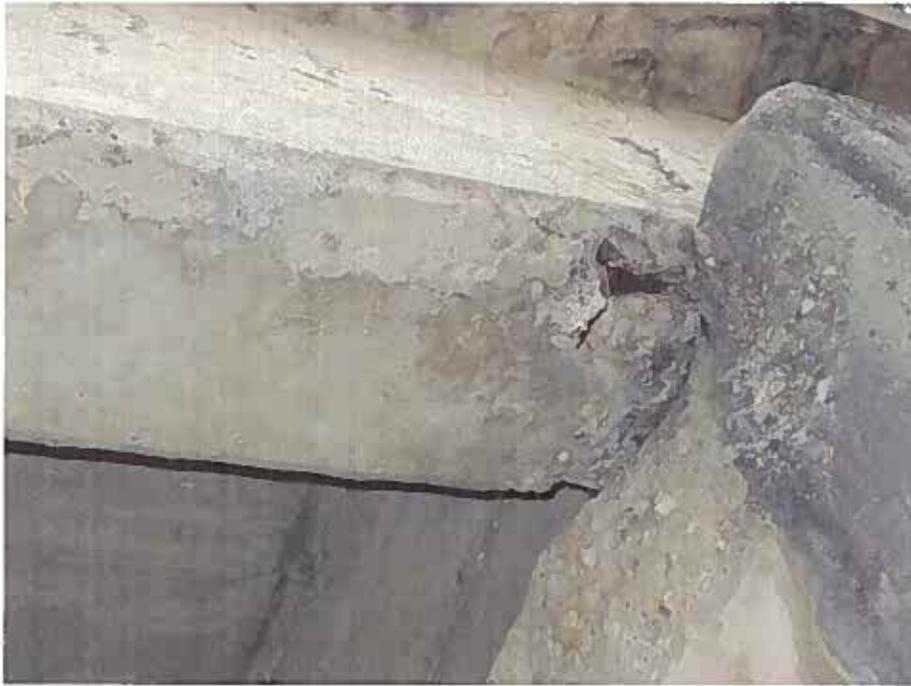
Exterior beam
Spalling is also occurring at the bearing of the exterior beams

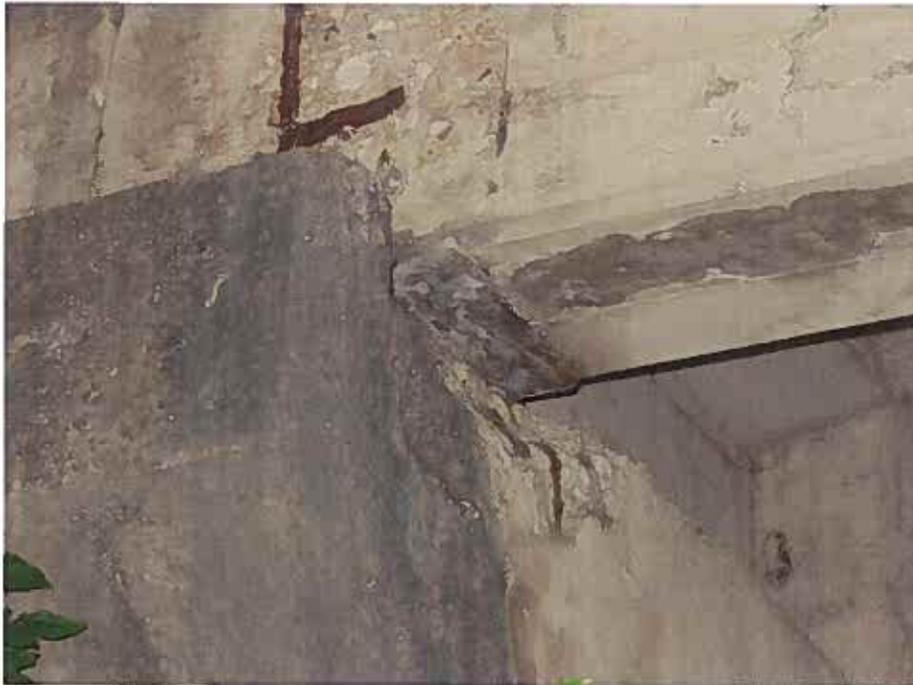
Exterior beam
Spalling of the bent cap
Note the lack of concrete cover on the reinforcement on the beam

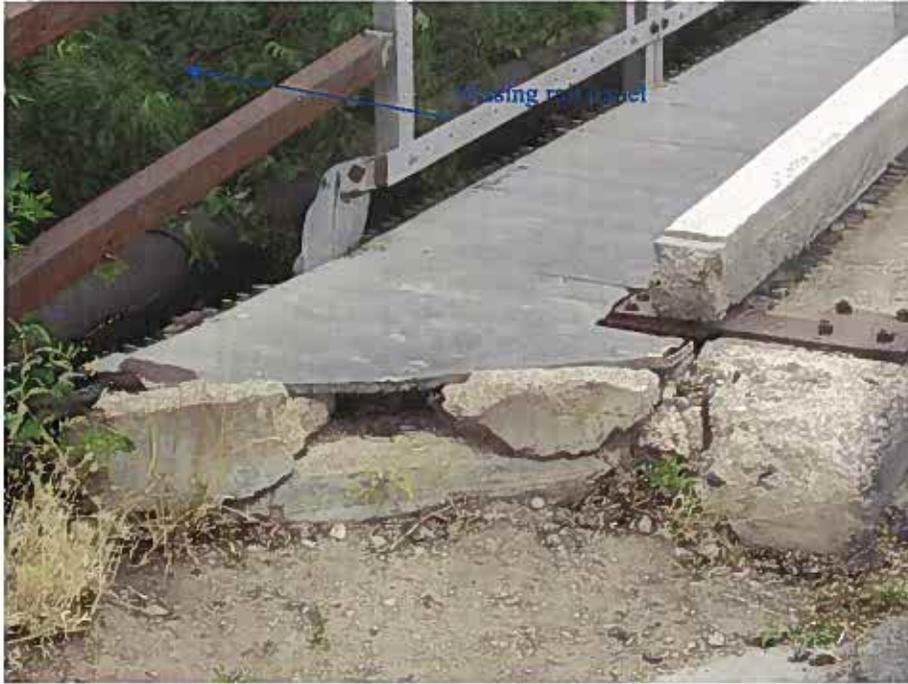
The sidewalk requires a lot of repairs

Recommendations: This structure is a good candidate for a pedestrian bridge in its present location, when repaired as listed below. Two repair methods are recommended for the approach spans; however a cost analysis will have to be performed to determine the most cost effective method. If it is desired to keep the sidewalk, a new pedestrian rail and steel grid decking is required as they are in poor condition.

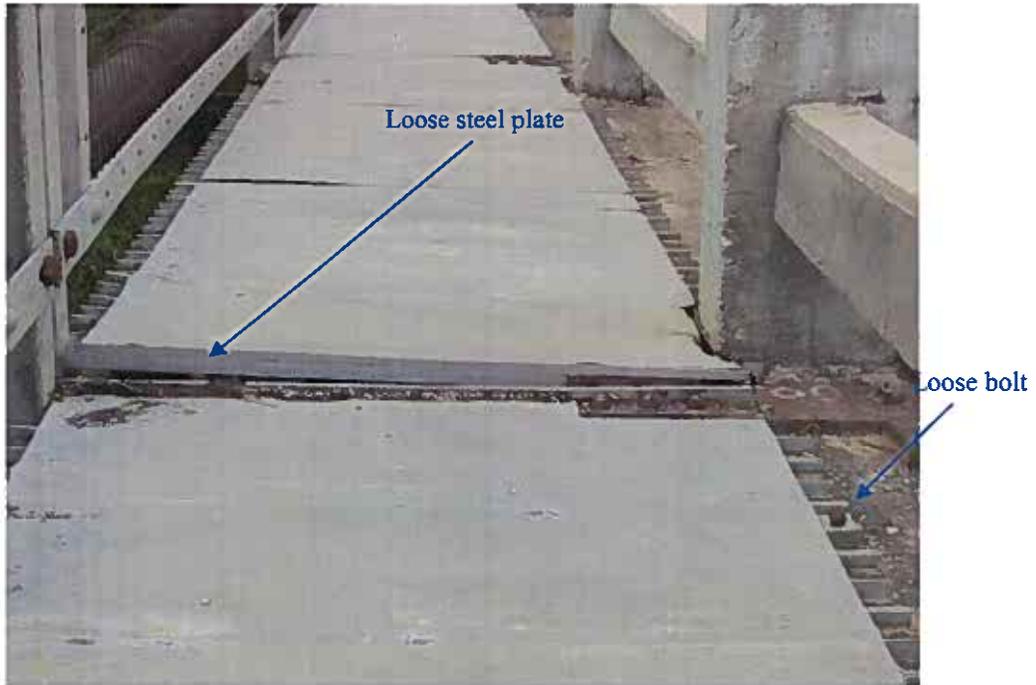
**The steel plates on top of the steel grid are not securely tight
The steel plate poses a safety concern**
