**CASE STUDIES ON  
THE REHABILITATION OF HISTORIC BRIDGES**

**American Association of State Highway  
and Transportation Officials (AASHTO)**

**The SRI Foundation  
Rio Rancho, New Mexico**

**July 5, 2011**

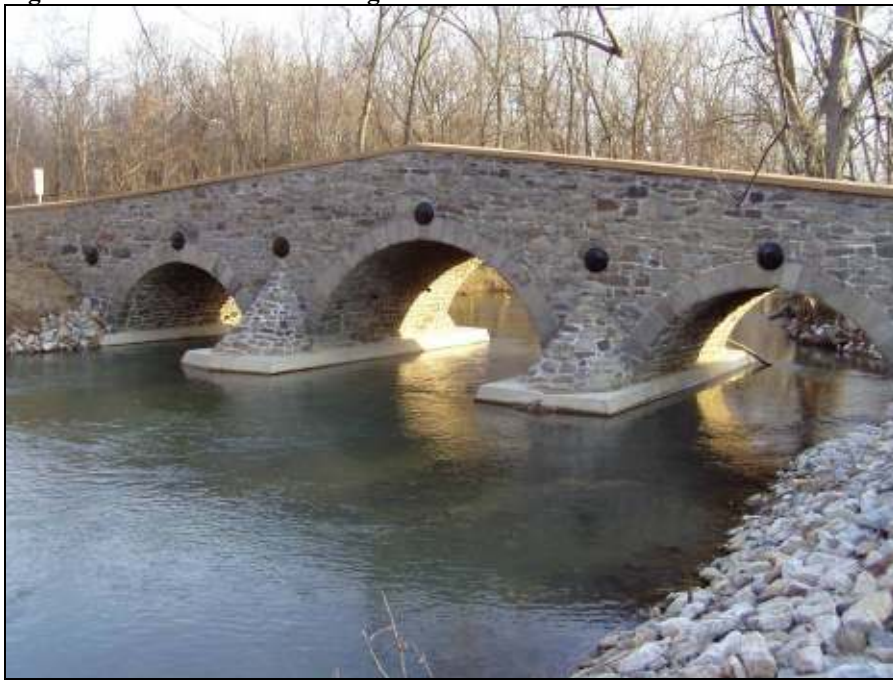
**Figure 1. Johns Burnt Mill Bridge**

In recent years, the bridge exhibited increased cracking in the arch barrels and spandrel walls, with a noticeable increase in cracking after a January 1996 flood. Inspection revealed that the fill above the arches had become saturated due to the flood waters. Freezing temperatures after the flood caused the saturated fill to expand, increasing the cracking in the arch barrels and spandrel walls. Scour of the stream bed at the piers also was observed during inspections.

The project began with a series of load tests, in addition to test borings into the bridge in order to determine the make-up and condition of the bridge's foundations. Based on these tests, the project team decided to use precast concrete backing blocks to strengthen the arches. A structural analysis

Periodic routine inspections of the bridge after completing the rehabilitation found no evidence of significant stone or mortar cracking or stone movement. These inspections demonstrated the value of using concrete backing blocks to strengthen the bridge.

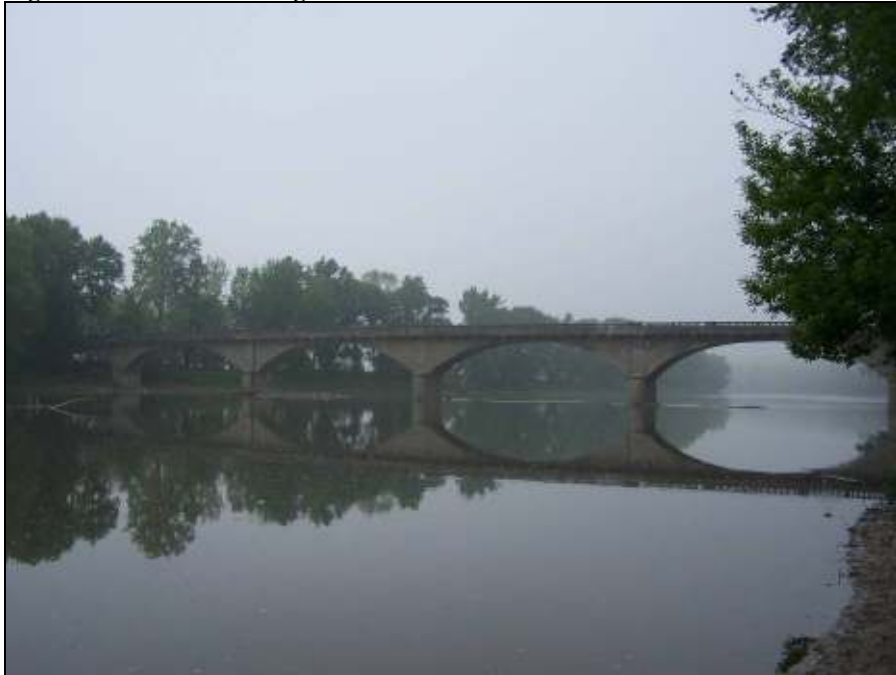
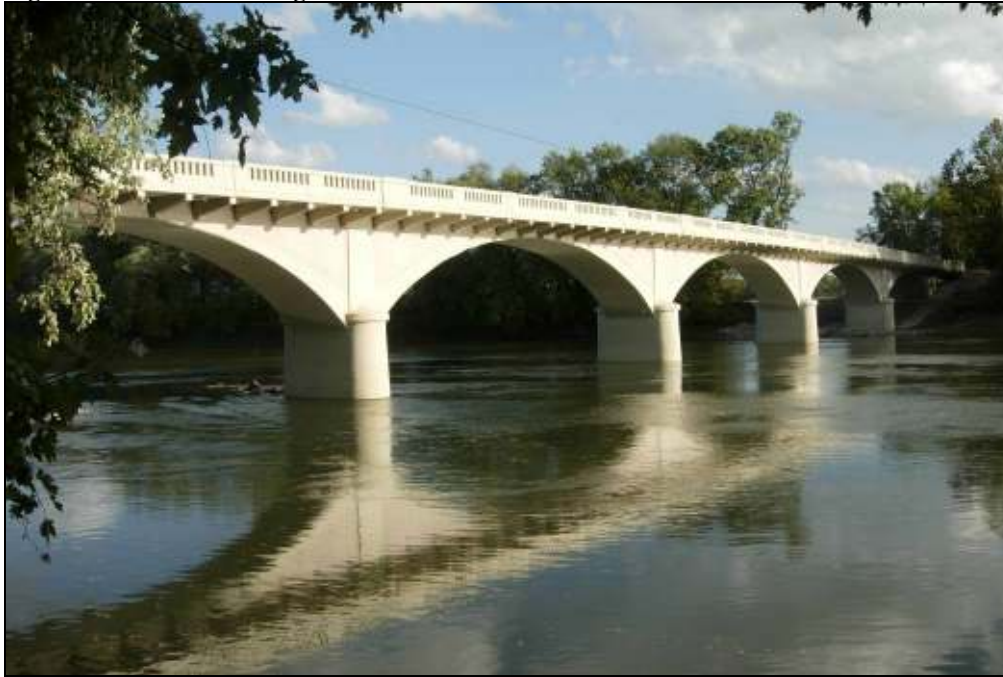
**Figure 4. Carrollton Bridge**

Since the existing bridge is listed in the National Register, it was extremely important that the external appearance of the structure not change any more than absolutely necessary. Due to the extreme deterioration of the pier shafts from freeze/thaw action, complete encasement was required as part of the rehabilitation. Self-consolidating concrete was used in the encasement of the piers in order to reduce the thickness of the encasement and to provide a more uniform appearance for the concrete surface. The use of this material was a first for the Indiana DOT LaPorte District.

The Carrollton Bridge provides a major river crossing for Carroll County residents, farmers, and commuters traveling to and from the city of Delphi. Very few structural repairs had been performed on this concrete arch bridge since its original construction in 1927. The bridge was considered functionally obsolete with a growing concern developing over the structural health of the bridge. Freeze/thaw damage was observed over much of the structure including the overhang brackets, pier stems, and arch rings. Concrete cracking and delaminations were resulting in section loss throughout the structure.

Incorporating a new continuous deck composite with the brackets and spandrel walls has an additional benefit. It helps distribute the load over a larger area, increases the load capacity of the arch rings, and stiffens the bridge against heavy truck loads. It also creates a concrete roof over the arch fill, thereby eliminating the ingress of moisture into the substructure and reducing the concrete’s deterioration due to freeze/thaw action.

The existing railing could not be replaced “in kind” and still meet current federal guidelines for crash tested bridge railing. Therefore, the Texas Type “T-411” railing was heavily modified to provide a similar appearance to the existing rail, but still providing the necessary strength and geometry to satisfy Federal Highway Administration (FHWA) crash standards. Thus, the railing emulated the look of the existing railing and meets crash test requirements.

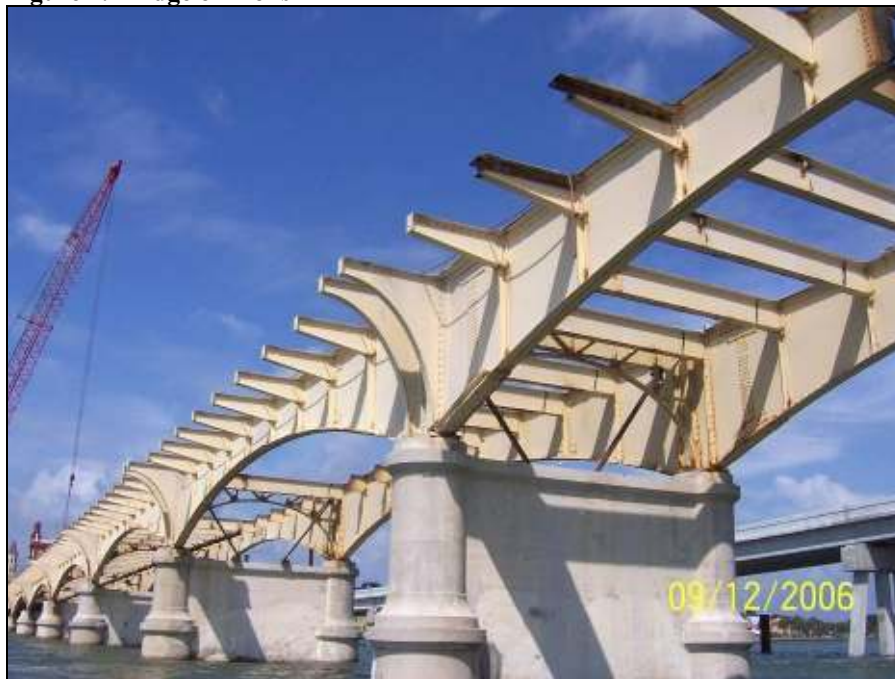
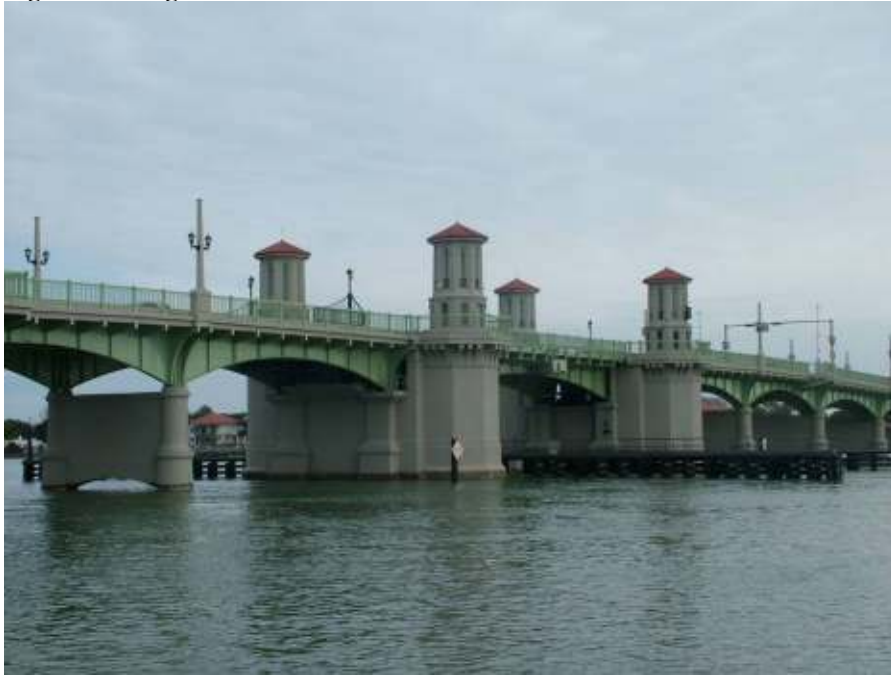
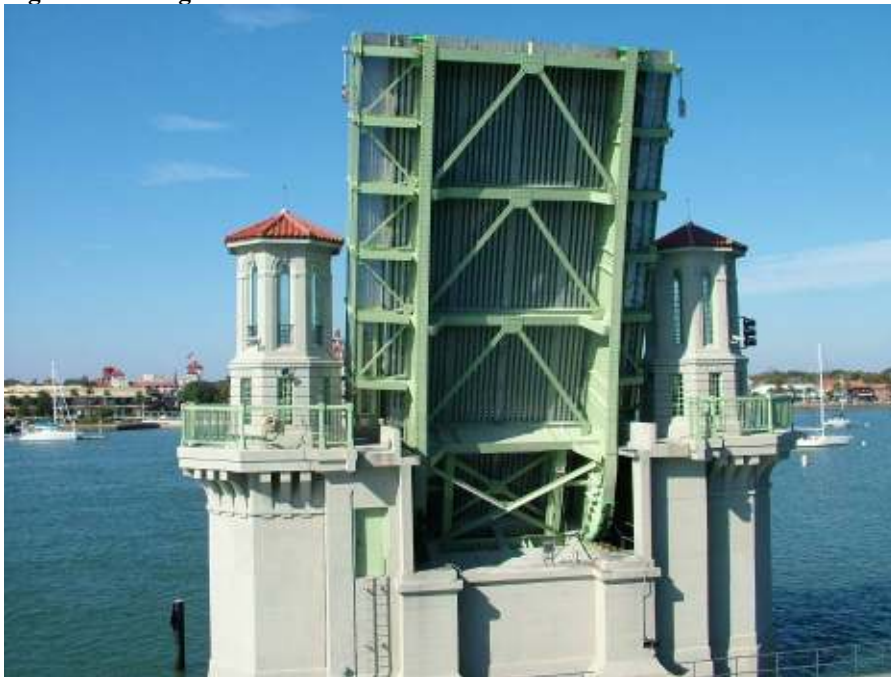
**Figure 7. Bridge of Lions**

Prior to rehabilitation, the bridge was in fair to poor condition, particularly in terms of the fracture critical girder-floorbeam approach spans and the substructure units. At many locations, crutch bents had been previously installed in order to provide additional support.

As part of the rehabilitation, the bridge's two fascia girders were retained for visual appearance, while new steel stringers were installed inside the girders. The fascia girders, which were removed, repaired, and then reset in place, were relieved of most of the loads and the new stringers now carry the majority of the dead load and the traffic loads. The stringers are hidden from view and will not distract from the architecturally significant arched girders. In addition, the approach spans were widened in order to improve the roadway geometry.

The bascule piers and associated towers were left in place and repaired. This included replacing the existing concrete piers within the splash zone with new concrete, as the existing concrete contained high levels of chlorides. The bascule piers were strengthened by the addition of drilled shafts, and a new footing was placed below the existing waterline footing in order to provide sufficient strength for a modern design scour event.

Several features original to the bridge, but previously removed or replaced, were replicated. These included the pedestrian railing (with the height increased to meet modern standards), light standards, and rotating traffic gates. The bridge steel was painted to match the original bridge color.

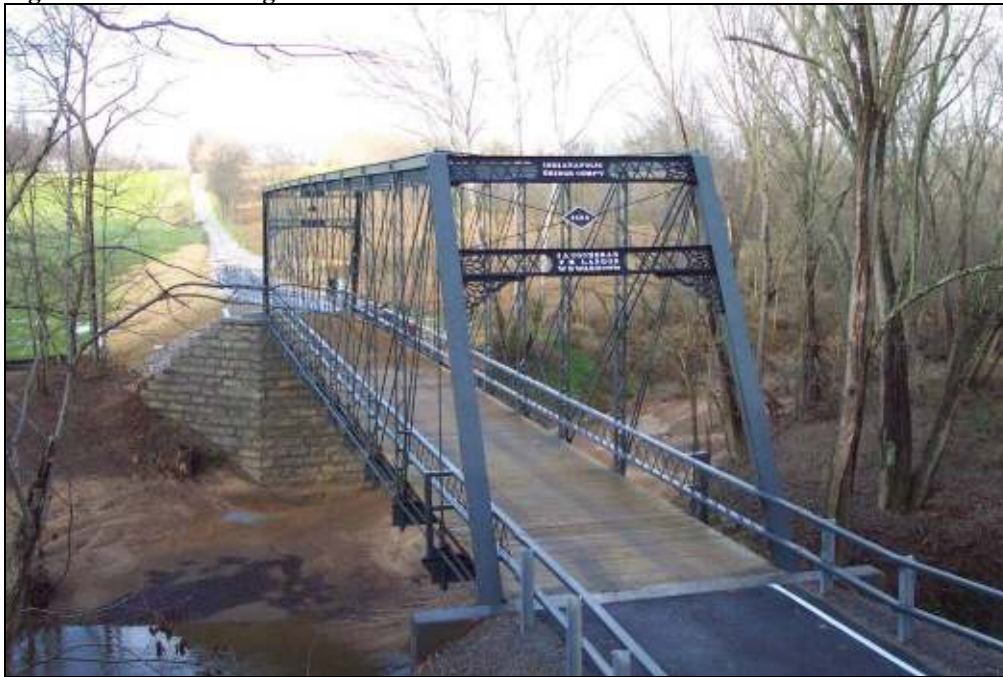
**Figure 11. Tobias Bridge**

The bridge's low load carrying capacity was controlled by the light design of the verticals, composed of Z-shaped plate commonly used by the railroads. The challenge was to develop a way to increase their capacity and preserve their distinctive detail, as well as repair those that were bent or bowed. After considering several schemes, a decision was made to install additional plate to the outside of each vertical. The plates were connected using high strength button head bolts to keep the look of the original rivets, but at a lesser cost. Heat straightening was used to repair out-of-plane members. The historic look of the lattice railings inside the truss lines was preserved by welding them to modern tubular railings, providing an adequate safety feature that maintains a historic appearance. Cracked members in the ornamented portal braces were repaired, and the bridge was cleaned and painted.

The project highlights several cost-effective rehabilitation techniques. Button head high-strength bolts were used instead of rivets as a more economical way to connect the new plates to the verticals. Heat straightening was used to bring members back into plane, demonstrating the cost effectiveness of this underused but cost-effect technique. Welding was used to repair cracks in the cast- and wrought-iron members in the portal braces, which, like the heat straightening, results in original fabric being conserved and preserved rather than replaced. The railings represent a practical solution by marrying old with new and providing a traffic railing that will also protect the truss lines.

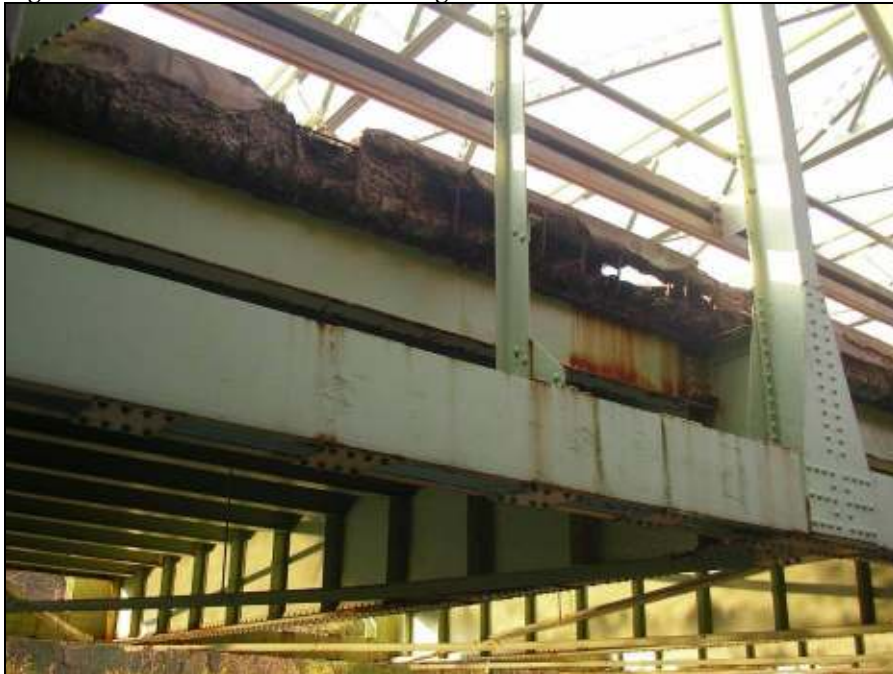
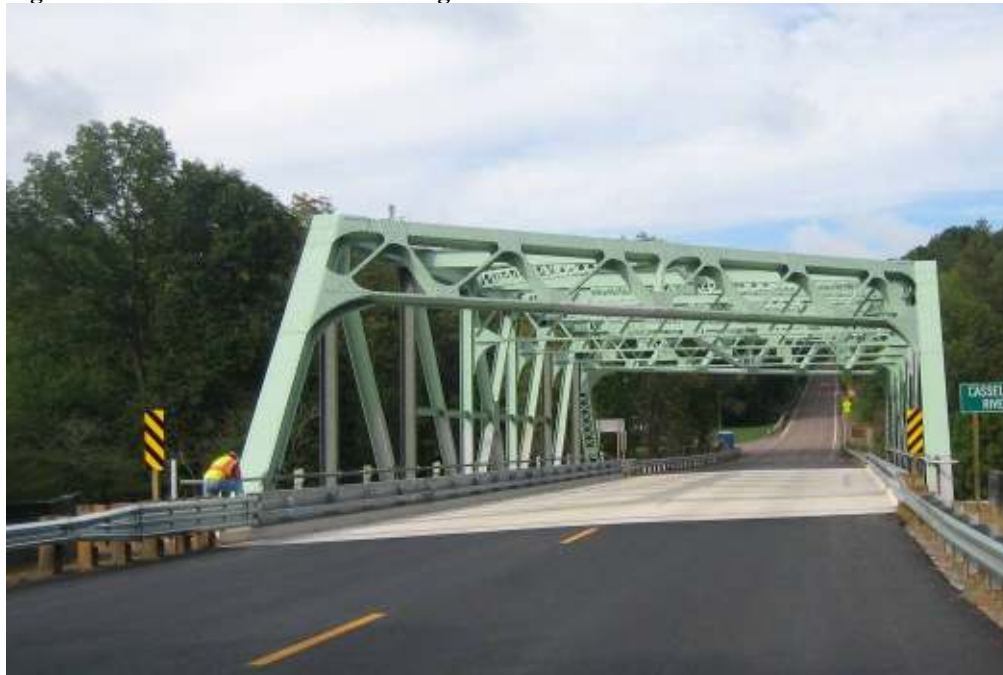
**Figure 12. New Casselman River Bridge**

By 2006, when detailed design work for rehabilitation of the New Casselman River Bridge began, the bridge was classified as structurally deficient. The classification was due to the poor condition of the concrete deck and deterioration in some of the steel members that comprise the truss superstructure. A thorough inspection of every element was performed to determine the condition of the bridge and ascertain the feasibility of rehabilitating the bridge. The inspection revealed several areas where the steel portions of the bridge had corroded and were deteriorated to the point where entire steel members needed to be replaced or strengthened. While this was significant, the overall condition of the steel portions of the bridge was good. The primary area of concern was the concrete deck, which had full depth punctures and required constant attention.

The New Casselman River Bridge was closed to traffic and the rehabilitation work commenced in June 2008. The concrete deck was removed and the rest of the bridge's superstructure exposed. A second inspection of the bridge was performed at this time to identify any additional areas of deterioration not seen during the original inspection. This second inspection revealed only a few

additional areas that needed repairs, and confirmed that the steel superstructure was in good condition despite its age and exposure to the weather.

- replacing in-kind the concrete deck slab,
- repairing and strengthening a number of the truss vertical members,
- replacing a number of the truss diagonals,
- replacing the exterior stringers supporting the concrete deck slab,
- cleaning and painting the entire steel superstructure,
- minor repairs and modifications to the concrete abutments supporting the truss, and
- placing rip rap around the base of the abutment supports to protect against scour.

Construction progressed throughout the summer of 2008. After the concrete deck was removed, all old paint was removed from the steel superstructure and the deteriorated members of the truss were repaired or replaced in-kind. Once the steel repairs were completed, the new concrete deck was formed and placed, and all the steel portions of the bridge were painted. A new two strand metal railing was installed to serve as a traffic barrier. This barrier meets current safety standards and maintains an “open feel” as motorists travel across the bridge. A special shield/splash guard behind the railing protects the steel truss members from exposure to road salts and will help preserve the bridge.

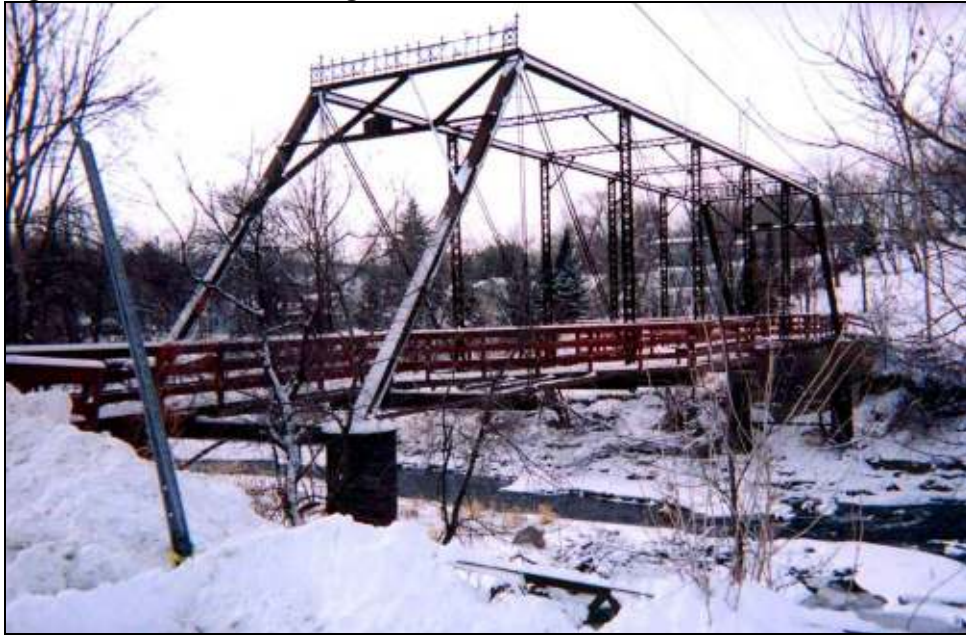
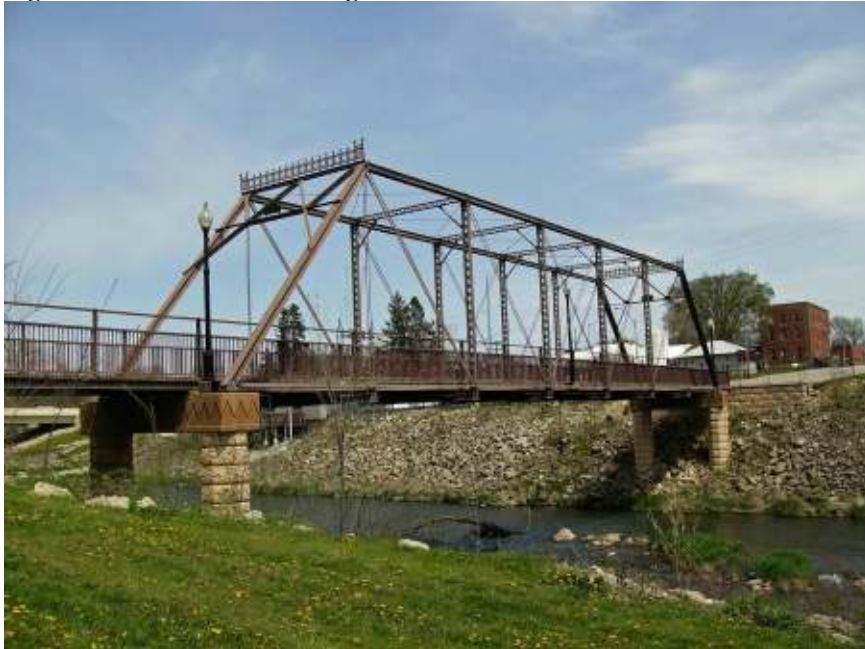
**Figure 14. Walnut Street Bridge**

The Walnut Street Bridge was converted to pedestrian use in 1978, but the bridge had been closed due to deterioration. The city wanted to preserve the bridge for continued pedestrian use, however, and as a result, initiated the structure's rehabilitation. Load rating analysis confirmed that the bridge met AASHTO pedestrian load requirements. A new bridge railing was selected to blend with the historic appearance of the existing truss and comply with Minnesota DOT and AASHTO design requirements for bicycle use. A new timber bridge deck was selected to minimize load.

A detailed inspection was performed to assess current deficiencies and needed repairs. Deteriorated bridge bearings, truss members, stringers, piers, and abutments were replaced to address that safety concerns that had closed the bridge. Repairs to the bottom chord were field connected with hex head bolts. Button head bolts were used for the upper chord repair in areas visible to pedestrians. Temporary bracing was used to support the truss during the chord repairs. The timber deck and railing were also replaced. New abutments and lengthened approach spans were designed to alleviate erosion problems that resulted from the area's steeply sloped banks. Formliners with architectural surface treatment and color staining were used on the new piers and abutments.

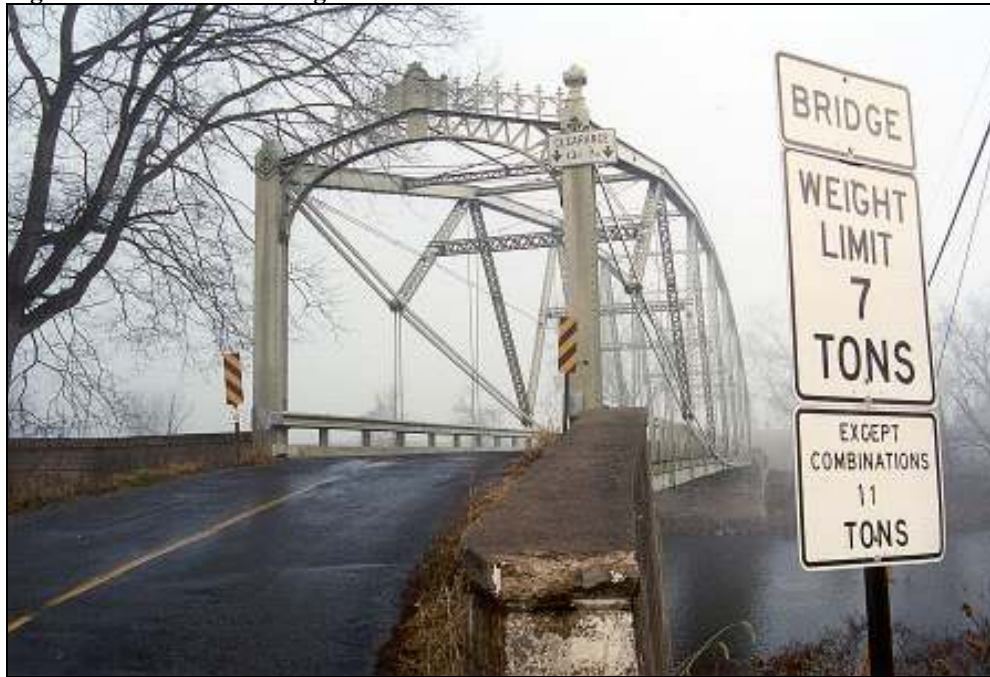
**Figure 16. Pine Creek Bridge**

The purpose of this project was to provide a crossing of Pine Creek that would satisfy the area's transportation needs for an extended period of time, while recognizing the historical significance of the bridge and the nearby Tiadaghton Elm. The bridge was classified as functionally obsolete due to its narrow width (16 feet 11 inches), which required the bridge to be single lane. Its primary structural members, the trusses, limited the bridge's width. The bridge also had an open steel deck which, especially in wet conditions, could result in vehicle tire slippage and loss of directional control. In addition, like all truss bridges, the Pine Creek Bridge features supported members adjacent to the roadway; if not adequately protected by a structural barrier, these could be damaged by a crash on the bridge. The non-redundant design of the truss could result in complete collapse of the span if a major support member were sufficiently damaged.

The vertical alignment approaching the bridge was also substandard, causing vehicles' undercarriages to frequently contact the pavement. The vertical alignment also resulted in inadequate sight distance for vehicles.
