April 25, 2008

Mr. Mark Hines
City of Waco
Engineering Services
401 Franklin Avenue
P O Box 2570 Waco, Texas 76701

Re: Historic Coating Color Investigation & Analysis of the
1901 Washington Avenue Bridge.

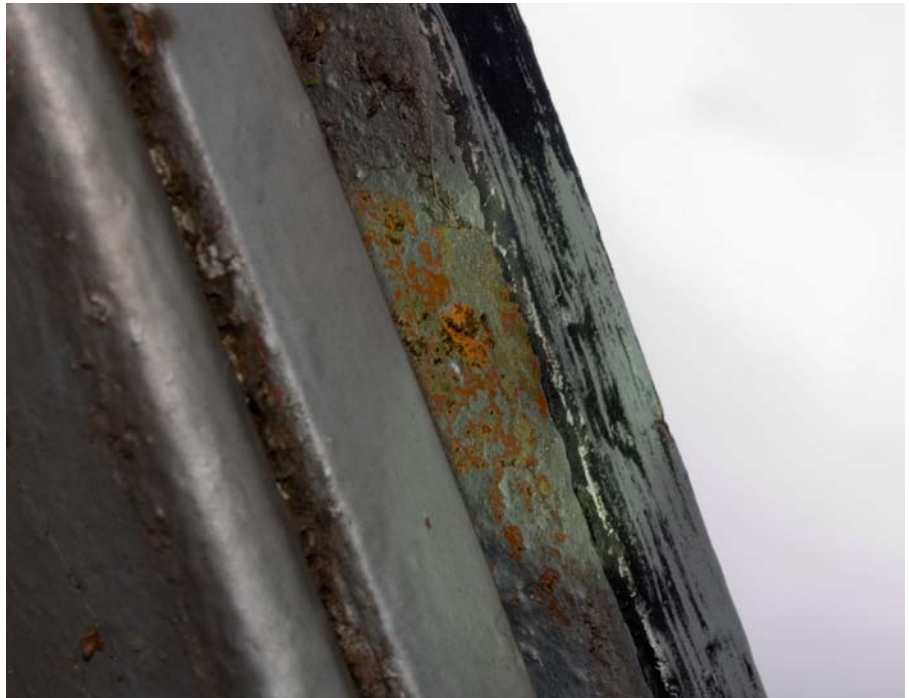
Most surfaces that were easily reached seemed to have been later blasted clean at previous treatments of the bridge. The second or next re-painting of the bridge appears to have been completed with a lead white primer on a rusty surface followed by aluminum paint. On top of that was found an orange primer followed by aluminum paint and at one time the bridge was painted with a green paint.

Black, orange, green and aluminum layers on back of plaque

For historical proposes it is recommend that a satin black coating be used to bring the landmark back to it's original 1902 color and sheen. In the photo archives the now gone light rail bridge and the Washington Avenue Bridge were nearly the same in appearance. The black paint used appears to be a phenolic drying oil with black pigment resembling a lamp black. An industrial coating system that could mock this original coating yet would be more durable to reduce future maintenance is a good idea in this case. Many of the National landmarks across America that I have been associated with and helped specify coatings have used these modern product lines from Sherwin Williams, DEVO, and Tnemec to name a few, have light energy
