April 25, 2008

Re: Historic Coating Color Investigation & Analysis of the  
1901 Washington Avenue Bridge.

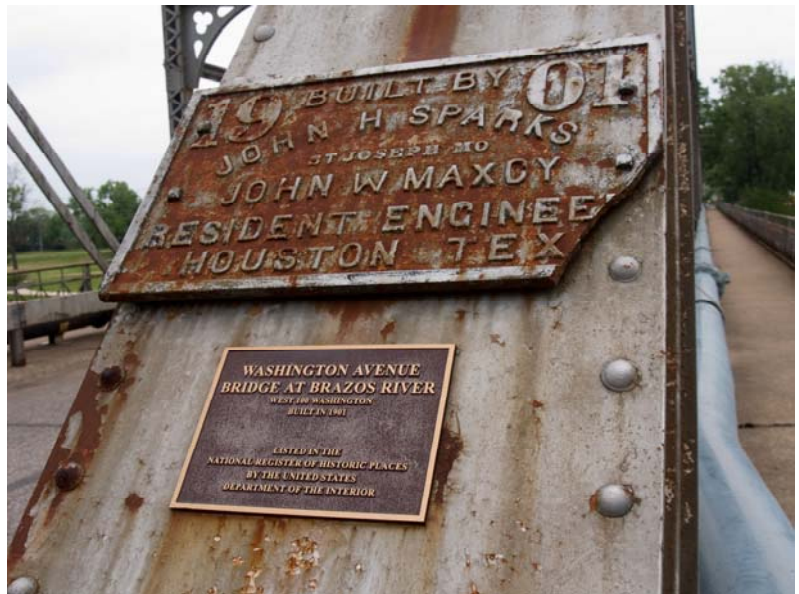
The investigation of the original coatings of the bridge started at the Texas Collections in the Carroll Library of Baylor University. With the help of Ellen Brown, curator of the collections, photographs of the bridge during and just after construction were found. Two portrait photos from 1902 with the work on the bridge in the background showed that the metal was not yet painted as is normal for hot riveted bridge construction. As well, the photos clearly displayed that the metal was uniformly oxidized. Other photographs from 1906 and 1908 were found and the bridge appears to be painted a monochrome black without decoration however the angles and details of the photos were not well suited for detecting any such embellishments. Later photos showed signs of chalking that turned the satin black a dull mottled black with dark

gray streaks. The latest photos were of the aluminum paint coating that most certainly was not the original coating.

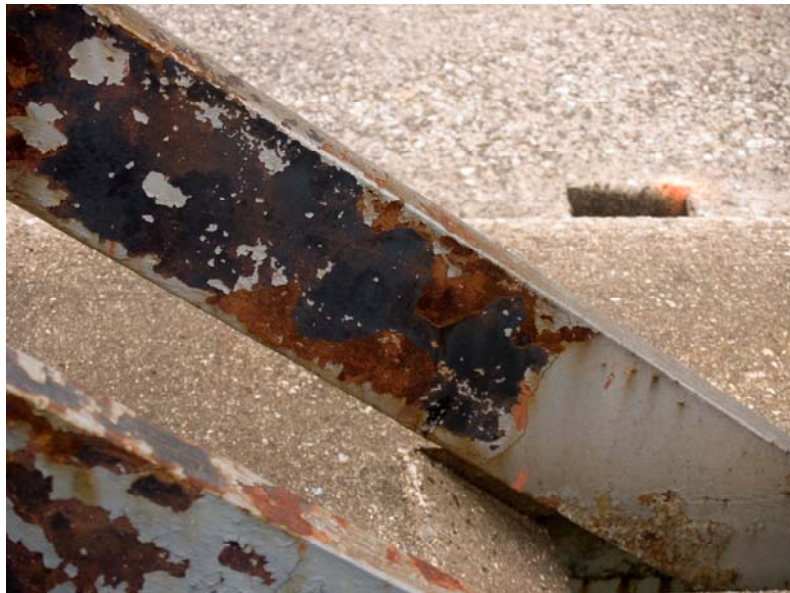
After two days with the bridge I was surmised that the bridge had never really been thoroughly sand blasted and even areas of separating and cleaving mill scale were found. Some of these were found to still retain the original thin black coating and were easily removed to be examined under magnification.

At 30x and 100x the samples were clearly that of the original black phenolic coating with no other coating found under it. Mill scale is formed during the quenching of the rolled steel to cool it, a thin blued skin

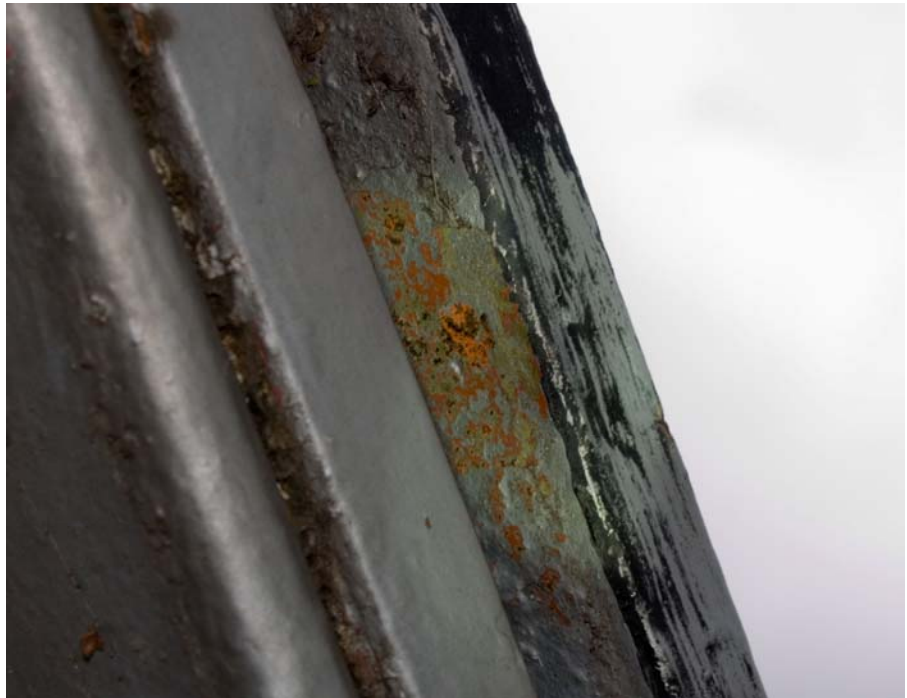
Most surfaces that were easily reached seemed to have been later blasted clean at previous treatments of the bridge. The second or next re-painting of the bridge appears to have been completed with a lead white primer on a rusty surface followed by aluminum paint. On top of that was found an orange primer followed by aluminum paint and at one time the bridge was painted with a green paint.

*Black, orange, green and aluminum layers on back of plaque*

For historical purposes it is recommended that a satin black coating be used to bring the landmark back to its original 1902 color and sheen. In the photo archives the now gone light rail bridge and the Washington Avenue Bridge were nearly the same in appearance. The black paint used appears to be a phenolic drying oil with black pigment resembling a lamp black. An industrial coating system that could mock this original coating yet would be more durable to reduce future maintenance is a good idea in this case. Many of the National landmarks across America that I have been associated with and helped specify coatings have used these modern product lines from Sherwin Williams, DEVO, and Tnemec to name a few, have light energy
